Lower Mississippi River Ports and Waterways Safety System (PAWSS) RF Coverage Test Results

technical report

November 1999

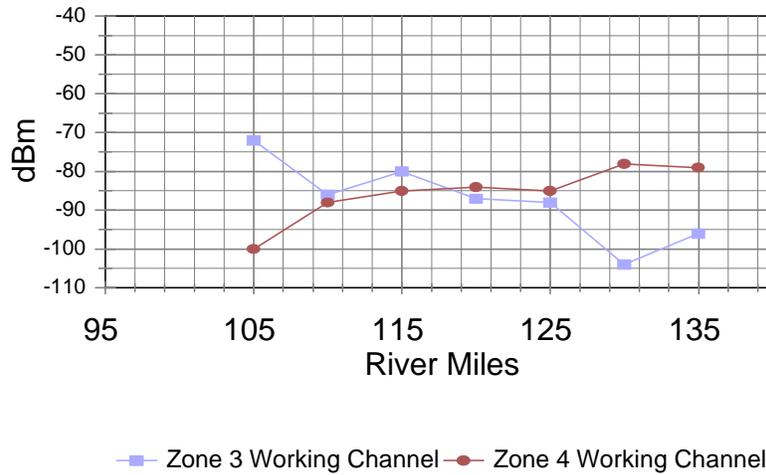
Graph 4B
Towers 4 and 3 Signal Overlap

Using -100 dBm as the reference point for overlapping signal strength between towers 3 and 4, Graph 4B shows that there should be sufficient signal strength for the AIS working channel from tower 3 located at MM 93 to tower 4 located at MM 150. Note that the signal strength graph for tower 4 is not symmetrical and that the measured signal strength for all three channels at the upper end (higher mile markers) is much weaker than the lower end (lower mile markers). This indicates that the optimal antenna azimuth position on the tower may be oriented to the south of tower 4, which results in a greater signal strength in that direction. During other tests, the Coast Guard has tracked transponders well out into the Gulf of Mexico and as far east as Pascagoula, Mississippi from tower four.

Graphs 4B also shows that the crossover point for the AIS working channel signal strength measurements between towers 3 and 4 occurred at MM 118. At that location, the signal power of the working channel was -85 dBm.
